PRESERVATION GUIDELINES

FOR MUNICIPALLY OWNED

HISTORIC BURIAL GROUNDS AND CEMETERIES

MASSACHUSETTS DEPARTMENT OF ENVIRONMENTAL MANAGEMENT
HISTORIC CEMETERIES PRESERVATION INITIATIVE

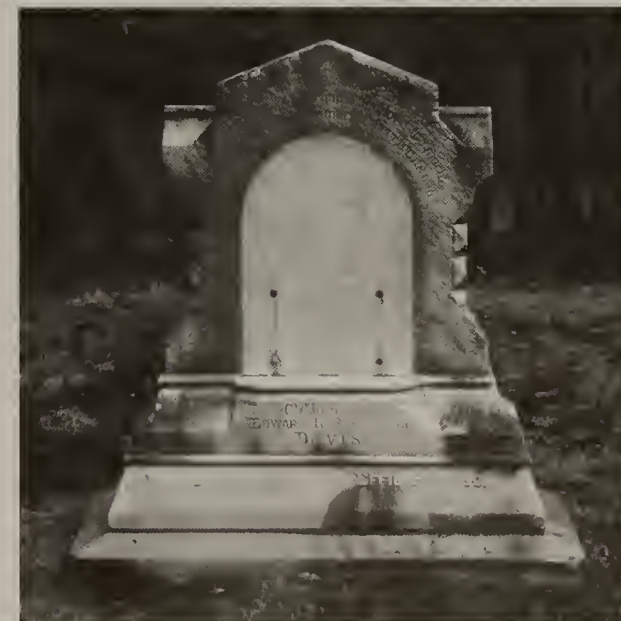
Steps

Marker vandalized by theft

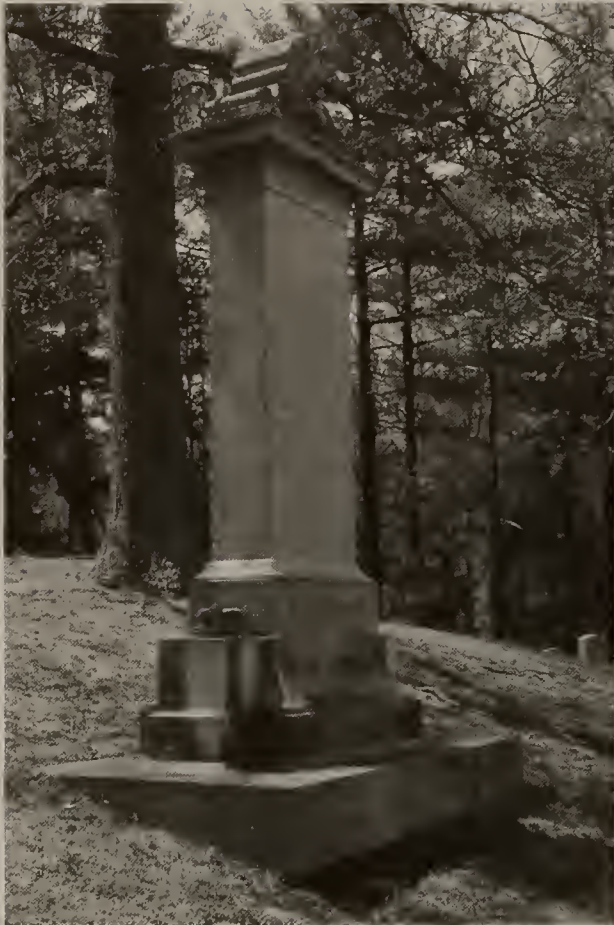
Exposed foundation of Emerson monument

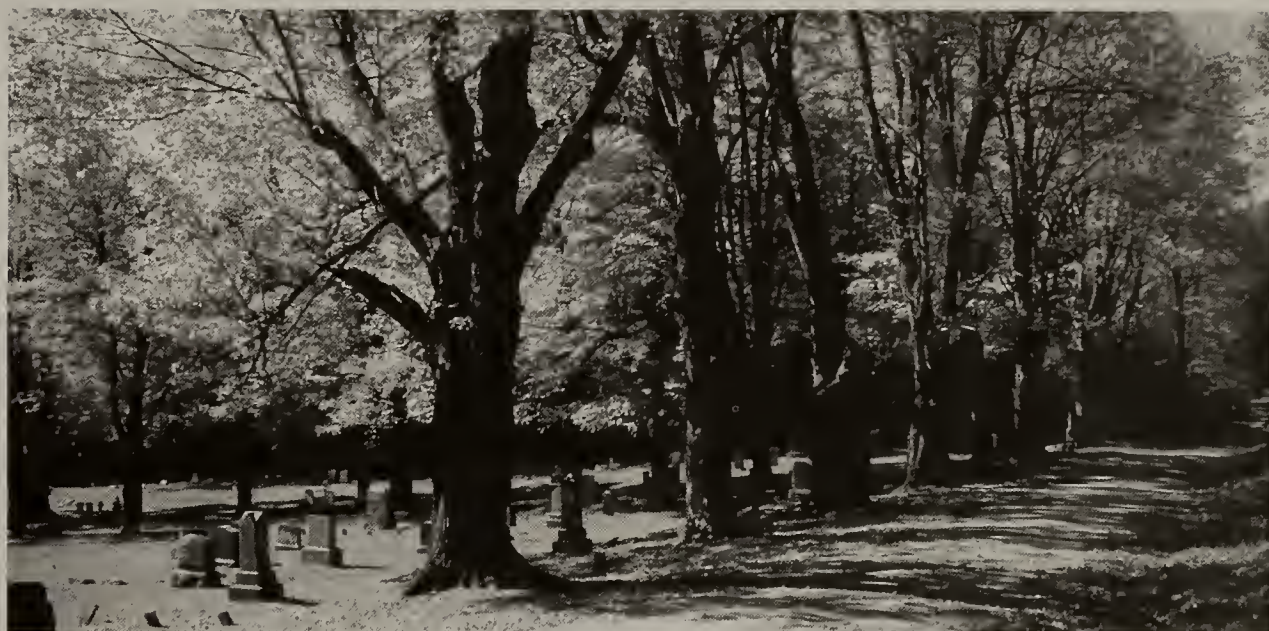
View west along Nillingdon Road

Lawns are in fair to poor condition with many small bare spots, moss and herbaceous weeds. Some slumping is evident on the steep south facing slopes. There are also mounds or small hummocks on these slopes that could be early burials.

Some erosion is also evident in relation to individual grave markers set parallel to steep slopes in the southern portion of the cemetery. Water flow has caused a build up of soils on the uphill sides of the grave markers and an erosion of soils on the downhill sides. This ultimately causes the grave markers to act as miniature retaining walls. Subject to the earth forces above, the markers ultimately lean downhill which creates a long term hazard for the resource. Areas of soil are exposed because a substantial vegetative ground cover has not been established due to the dense shade in this area.

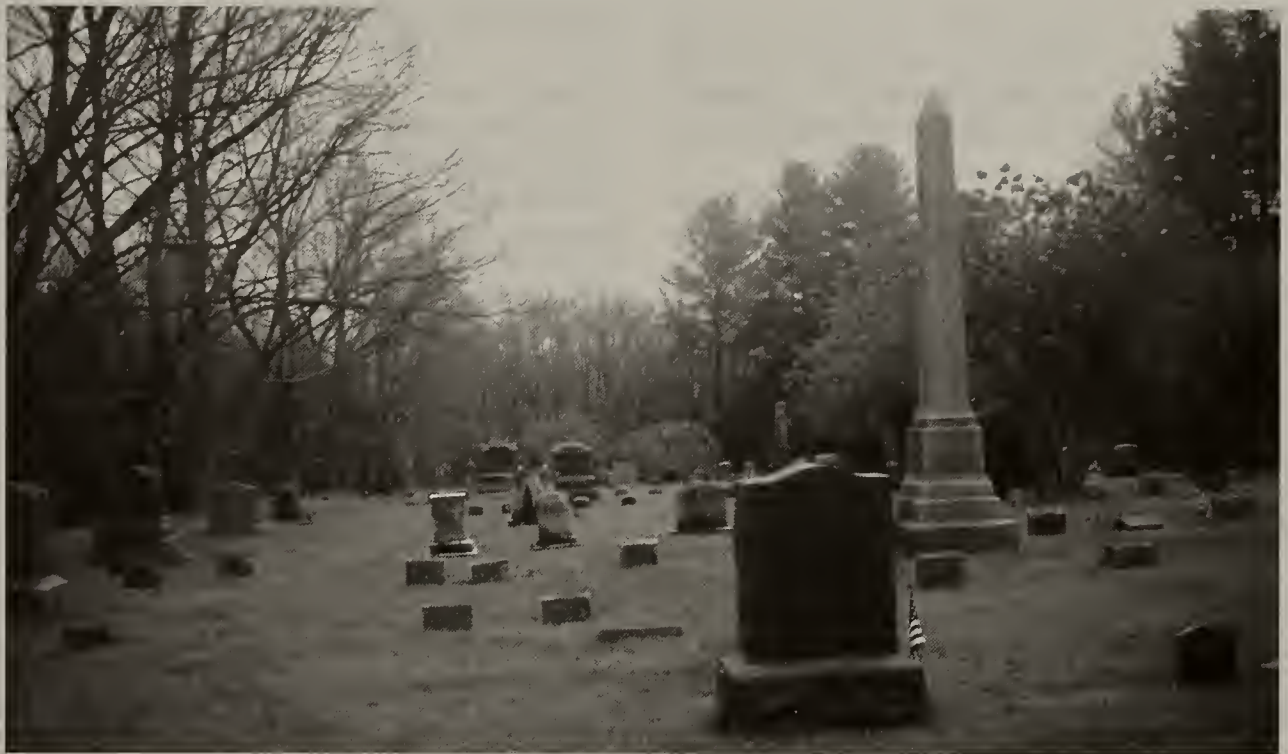
It appears that these trees have had some pruning in the past 5 years because of some old pruning wounds. However, large amounts of deadwood have accumulated since. A number of trees have codominant and multiple main stems like those in Center Cemetery. Ringville Cemetery does not have the same shade problems that Center Cemetery has.

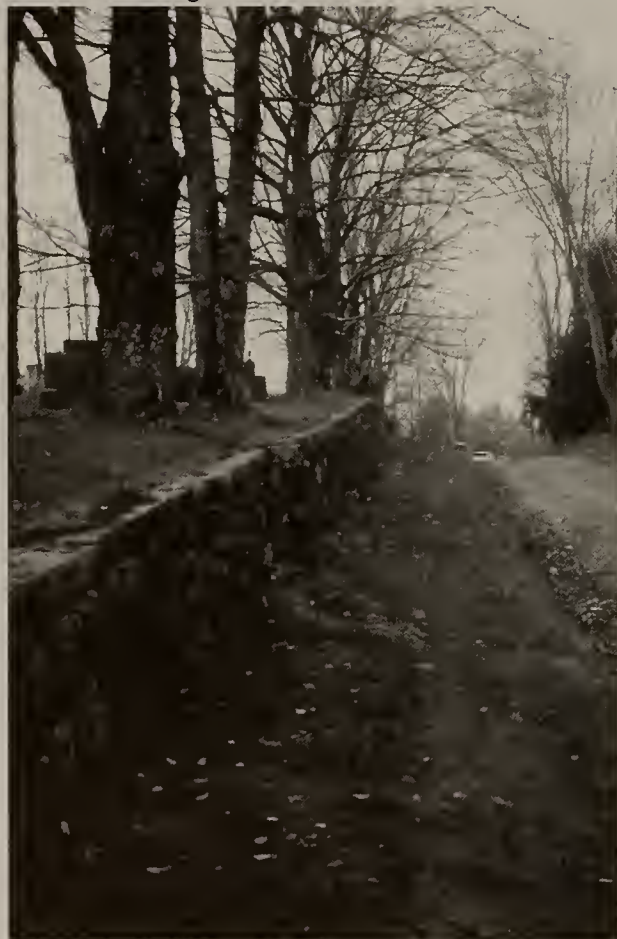
Ringville Cemetery, Stone wall along Witt Hill Road

The dry laid rubble stone retaining wall along Witt Hill Road at Ringville Cemetery was built about 1900 with stone hauled by oxen and wagons from West Chesterfield Gorge, 8 to 9 miles away. It appears to have been built in two stages with a slightly different character for each. The west end appears to be relatively level with a vertical face while the sloping east end has about a 6" batter on the face. Overall, the wall appears to be in stable condition with some slight shifting of the granite cap stones that are about 4" thick, 16 to 20" wide and very long, with one about 21' long.
